PHOTOGRAPHIC INTELLIGENCE REPORT

SHENYANG ARSENALS/ARMAMENTS PLANTS
SHENYANG, CHINA

CIA/PIR 65028

DATE September 1965

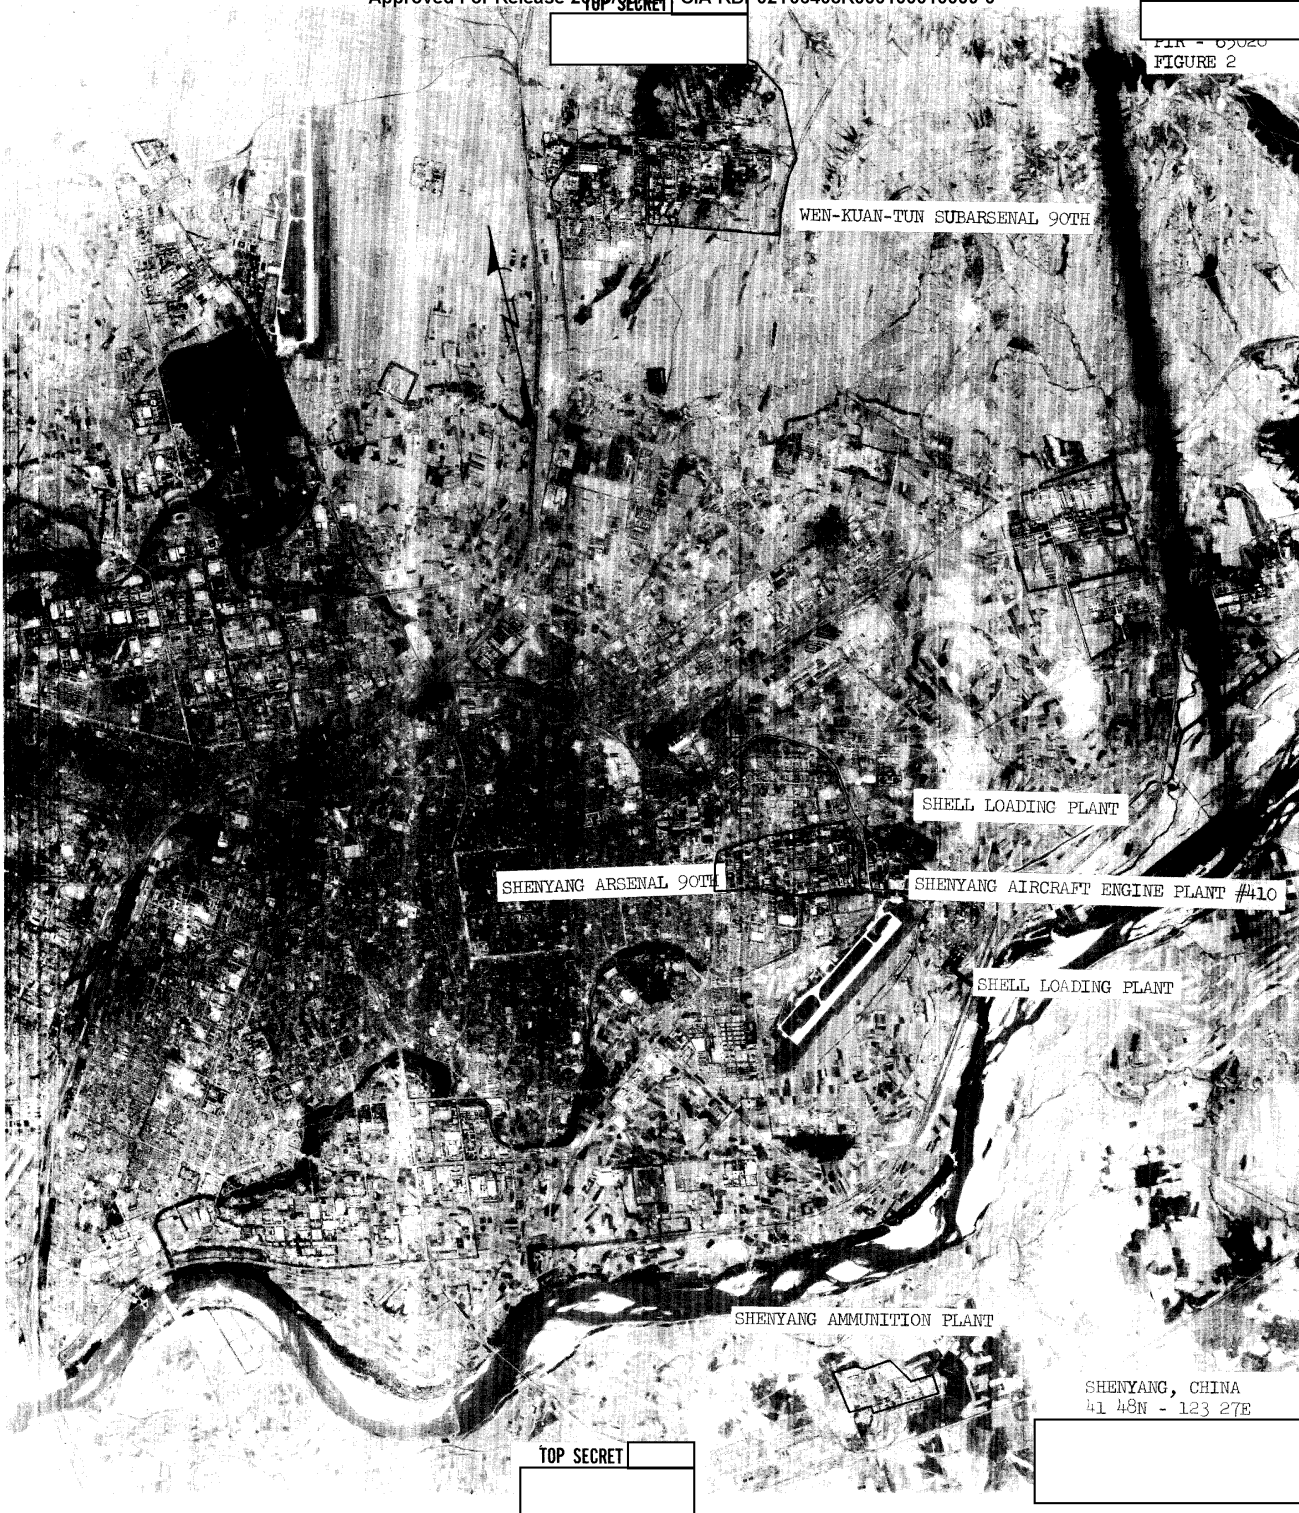
PIR - 05020
FIGURE 2

Shenyang (Mukden), a major industrial center in Southern Manchuria, located at geographic coordinates 41 48N - 123 27E, is one of the most prominent armaments and munitions manufacturing centers in China. Four plants: Shenyang Arsenal 90th, Wen-kuan-tun Subarsenal 90th, Shenyang Ammunition Plant, and an unidentified shell loading plant are reportedly engaged in significant production of this type. On Figure 2, each of these installations is outlined and identified.

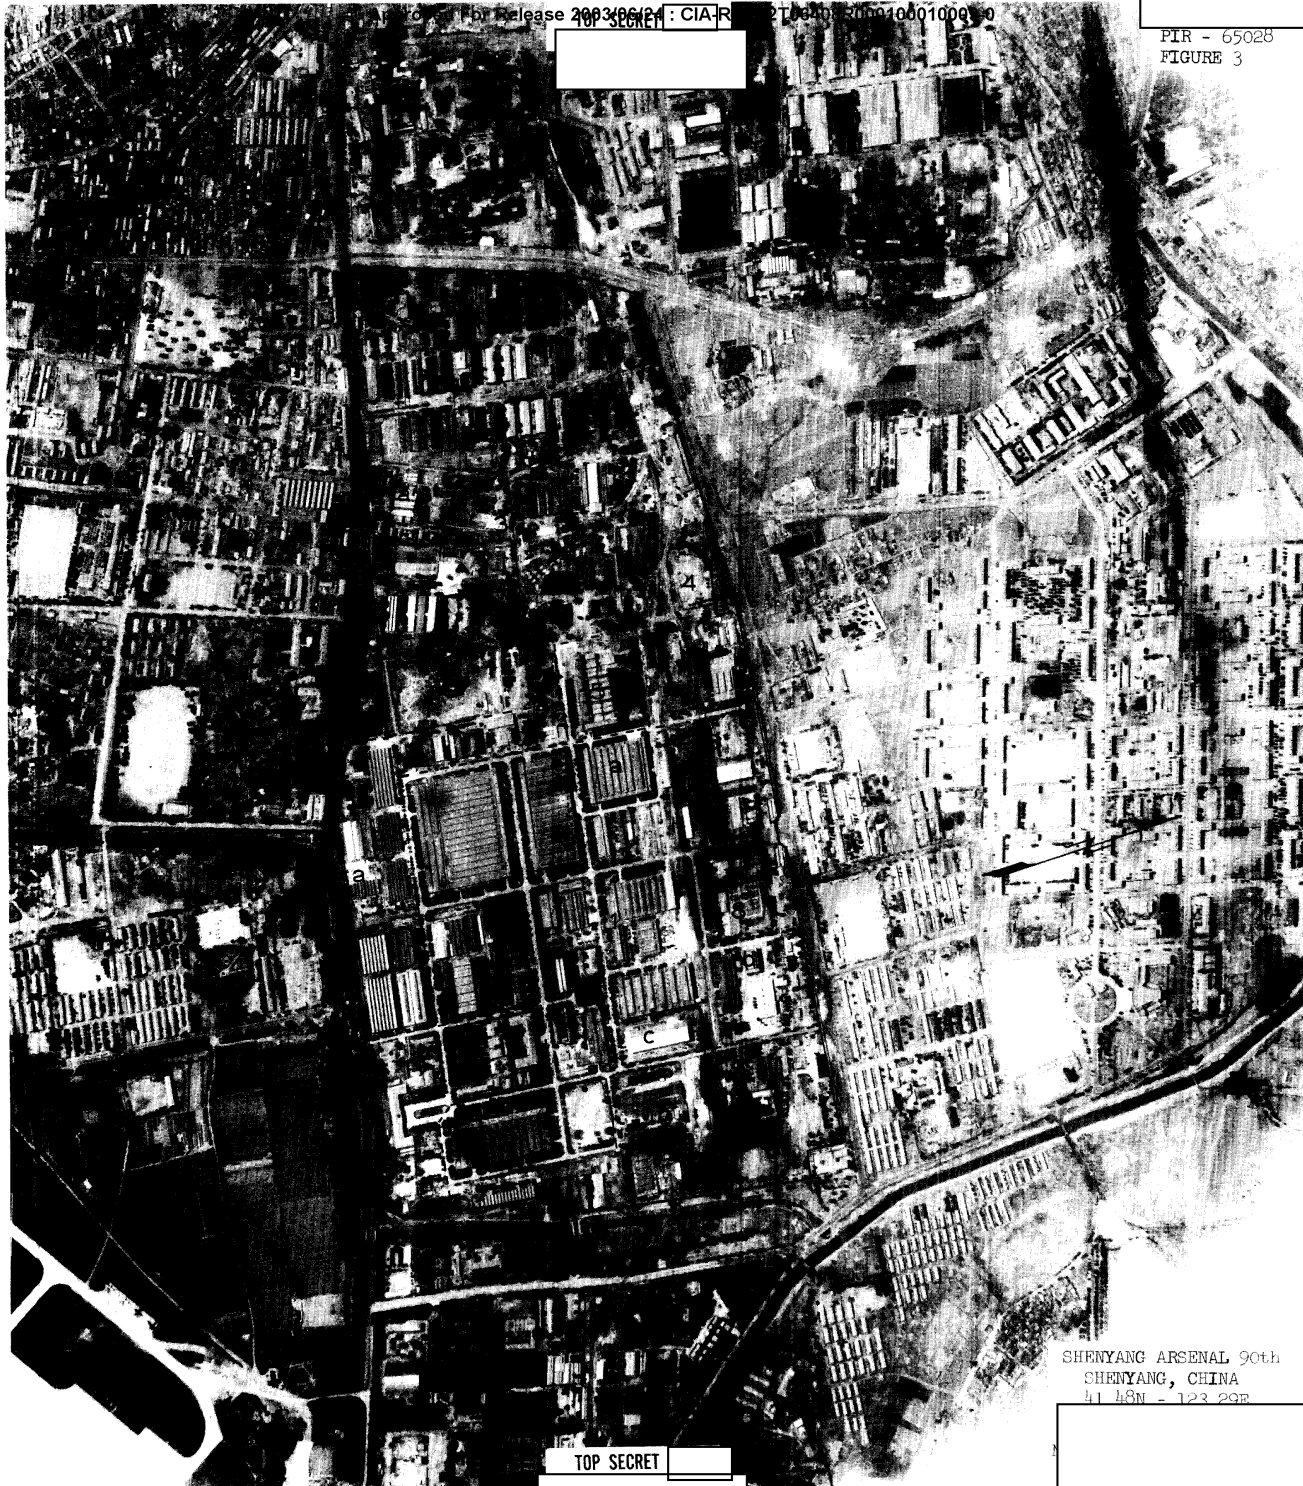
PIR - 65028
FIGURE 3

Generally, buildings at this plant site are characteristic of types encountered in light fabrication. Item numbers in the following section are keyed to the outlined buildings or areas on Figure 3.

- (1) Administration area, two large administrative type structures and several small support and service buildings
- (2) Machine shop area, thirteen sawtooth or monitor roofed shop type buildings, several small probable storehouses, and one large irregularly shaped unidentified building
- (3) Multi-purpose rail served area, containing warehouses, open storage, a boiler house, several shop buildings

- (a) Former thermal power plant, converted to engine test building
- (b) Separately secured area containing small unidentified building and a storage tank

- (4) Fuel storage, blending and control station; served by a rail tank car unloading rack
- (5) Engine test building, contains ten test cells
- (6) Warehousing/shop area with open coal storage and small administration buildings by main gate - on several missions large unidentified objects [redacted] were observed in open storage or on flat cars
- (7) Possible test building, rail served and fenced
- (8) Power substation, separately fenced
- (9) Thermal power plant with coal preparation and storage facilities
- (10) Metals processing section, large workshop, foundry, furnace building, and open storage
- (11) Main plant production area, several large fabrication/assembly buildings, many smaller workshops/machine shops, one boiler house, one possible forge, warehouses, and small support buildings

SHENYANG ARSENAL 90th
SHENYANG, CHINA
41 48N - 123 29E

Between [redacted] much of the arsenal was entirely rebuilt. The only significant features remaining basically unchanged were the machine shop area (item 2) and the metals processing area (item 10). By 1956, the plant layout appeared quite similar to that of [redacted]

Between [redacted] and [redacted] major changes consisted of one large fabrication/assembly building (item 11a), engine test building (item 5), conversion of power plant into engine test facility (item 3a), completion of construction on the probable POL unloading and storage area (item 4), a large shop building (item 11c), and a new shop in place of a previously existing one (item 2a).

Between [redacted] there were no major additions in the production areas. Construction in progress in [redacted] on the two north cells of the engine test building (item 5), a small probable shop (item 11b), and probable coal handling facilities near the power plant (item 9) has been completed. No major new construction has been started at this installation since coverage of [redacted]

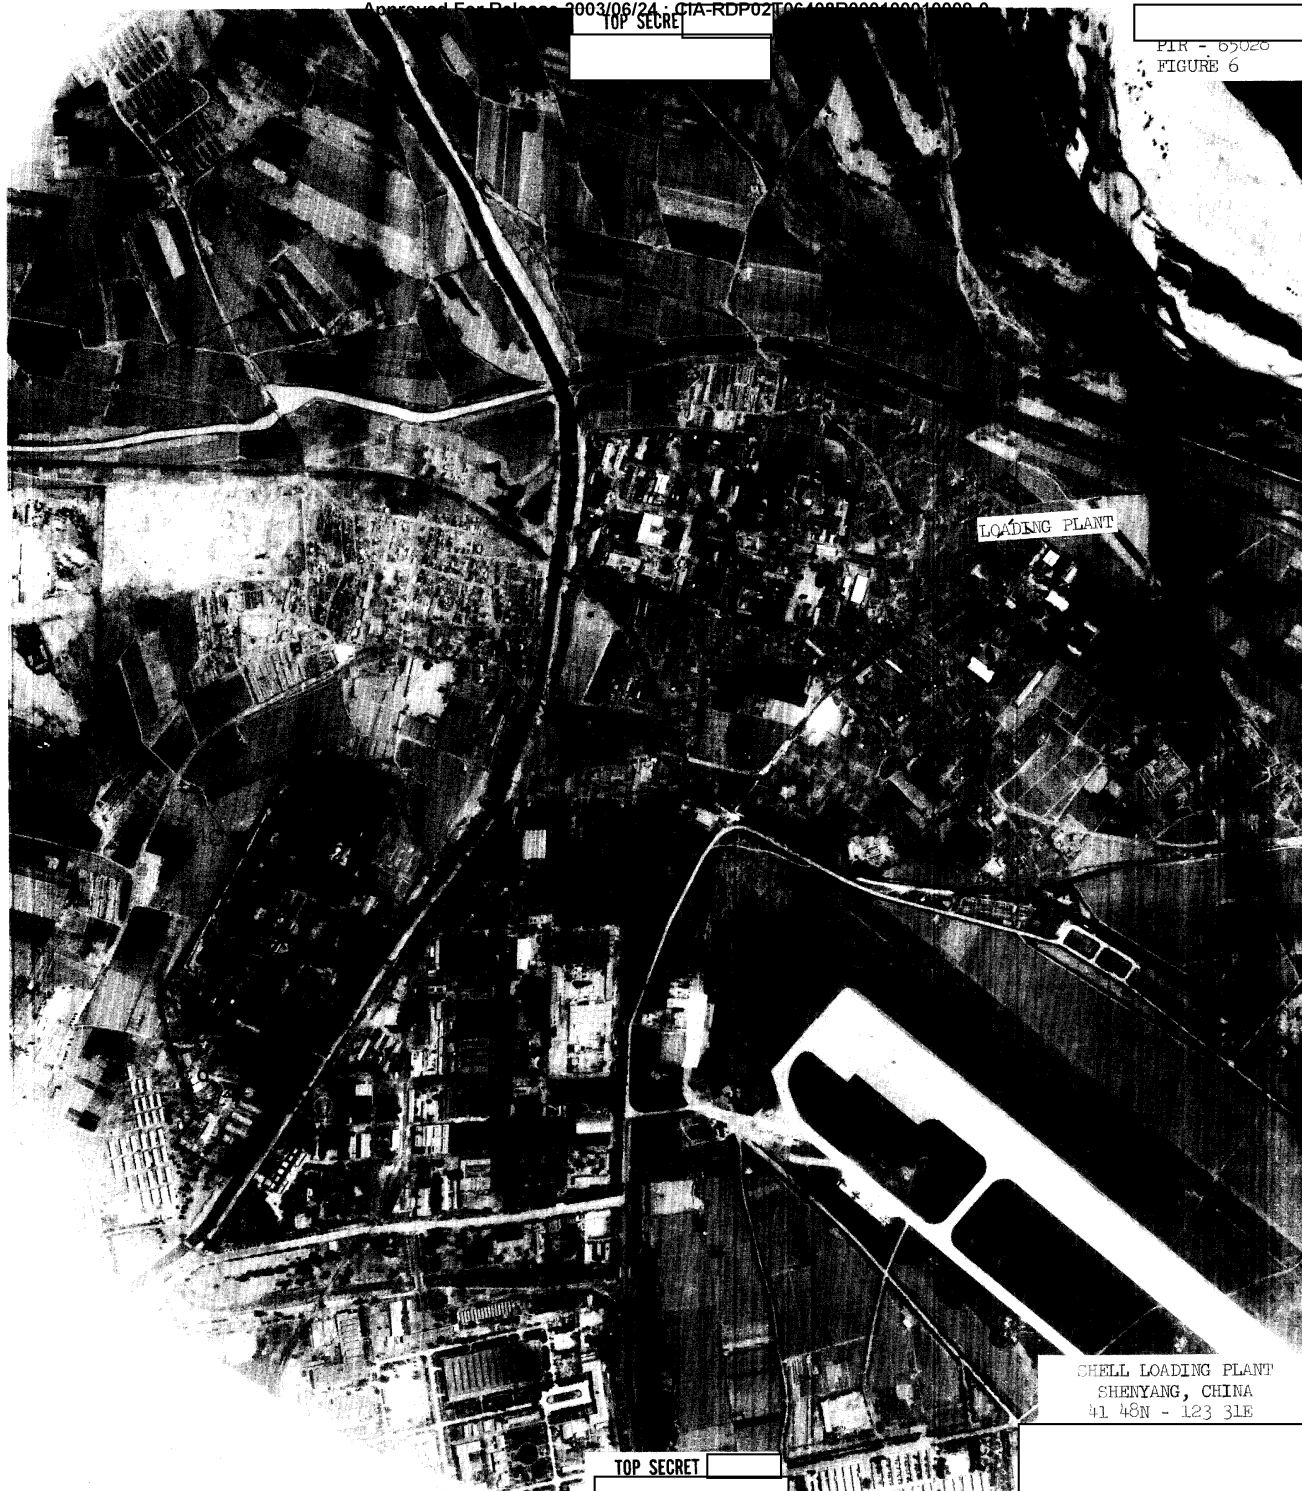
PIR - 65026
FIGURE 6

The fenced plant area is irregular in shape with maximum dimensions of approximately 2,400 feet by 900 feet, oriented NW-SE. The buildings present in this installation are small revetted processing and storage structures plus non-protected support facilities. The following descriptions are keyed to Figure 6.

- (1) Explosives storage area, seven revetted buildings
- (2) Explosives processing area, possibly for simple bursting charge loading operation, three revetted buildings, two of which are interconnected, plus two small service buildings
- (3) Support facilities, warehouses for inert storage, one large shop, administration building, several smaller probable shops and service buildings, and coal storage
- (4) Support area, several warehouse and shop buildings, boiler house,

- two small unidentified interconnected buildings (item 4a) of which one section is multistoried, and a lattice tower adjacent to these buildings
- (5) Probable initiator loading, group of small heavily revetted interconnected buildings
 - (6) Probable loading line for other components (fuzes, primers, etc.), includes probable pelleting building, assembly building, storage magazines, and non-revetted probable storage and service buildings.
 - (7) Boiler house
 - (8) Loading line, possibly for small caliber ammunition
 - (9) Ballistic test range area, with 300 meter covered range, several small service buildings, two revetted magazines
 - (10) Possible distruction point for faulty munitions

SHELL LOADING PLANT
SHENYANG, CHINA
41 48N - 123 31E

Changes in the facilities at this plant have been only slight to moderate over a period of many years. Between [] several small probable processing buildings were added in the initiator area (item 5), a boiler house was built in a support area (item 4), an administration building was added (item 3), additions and changes to two probable storage buildings (item 8) converted this area into a probable loading line, and a new probable processing building was erected in a previously existing revettment, (item 2). Between [] the covered test range was constructed (item 9), a large shop building was erected (item 4), and a portion of the unidentified installation in area 4 (item 4a) was built. Since [] the only changes have occurred in area 4. The large shop building constructed between [] has been replaced by a much smaller structure and further additions have been made in the NE corner of this area (item 4a).

A small nearby shell loading plant is also outlined on Figure 6, but is not discussed in this report.

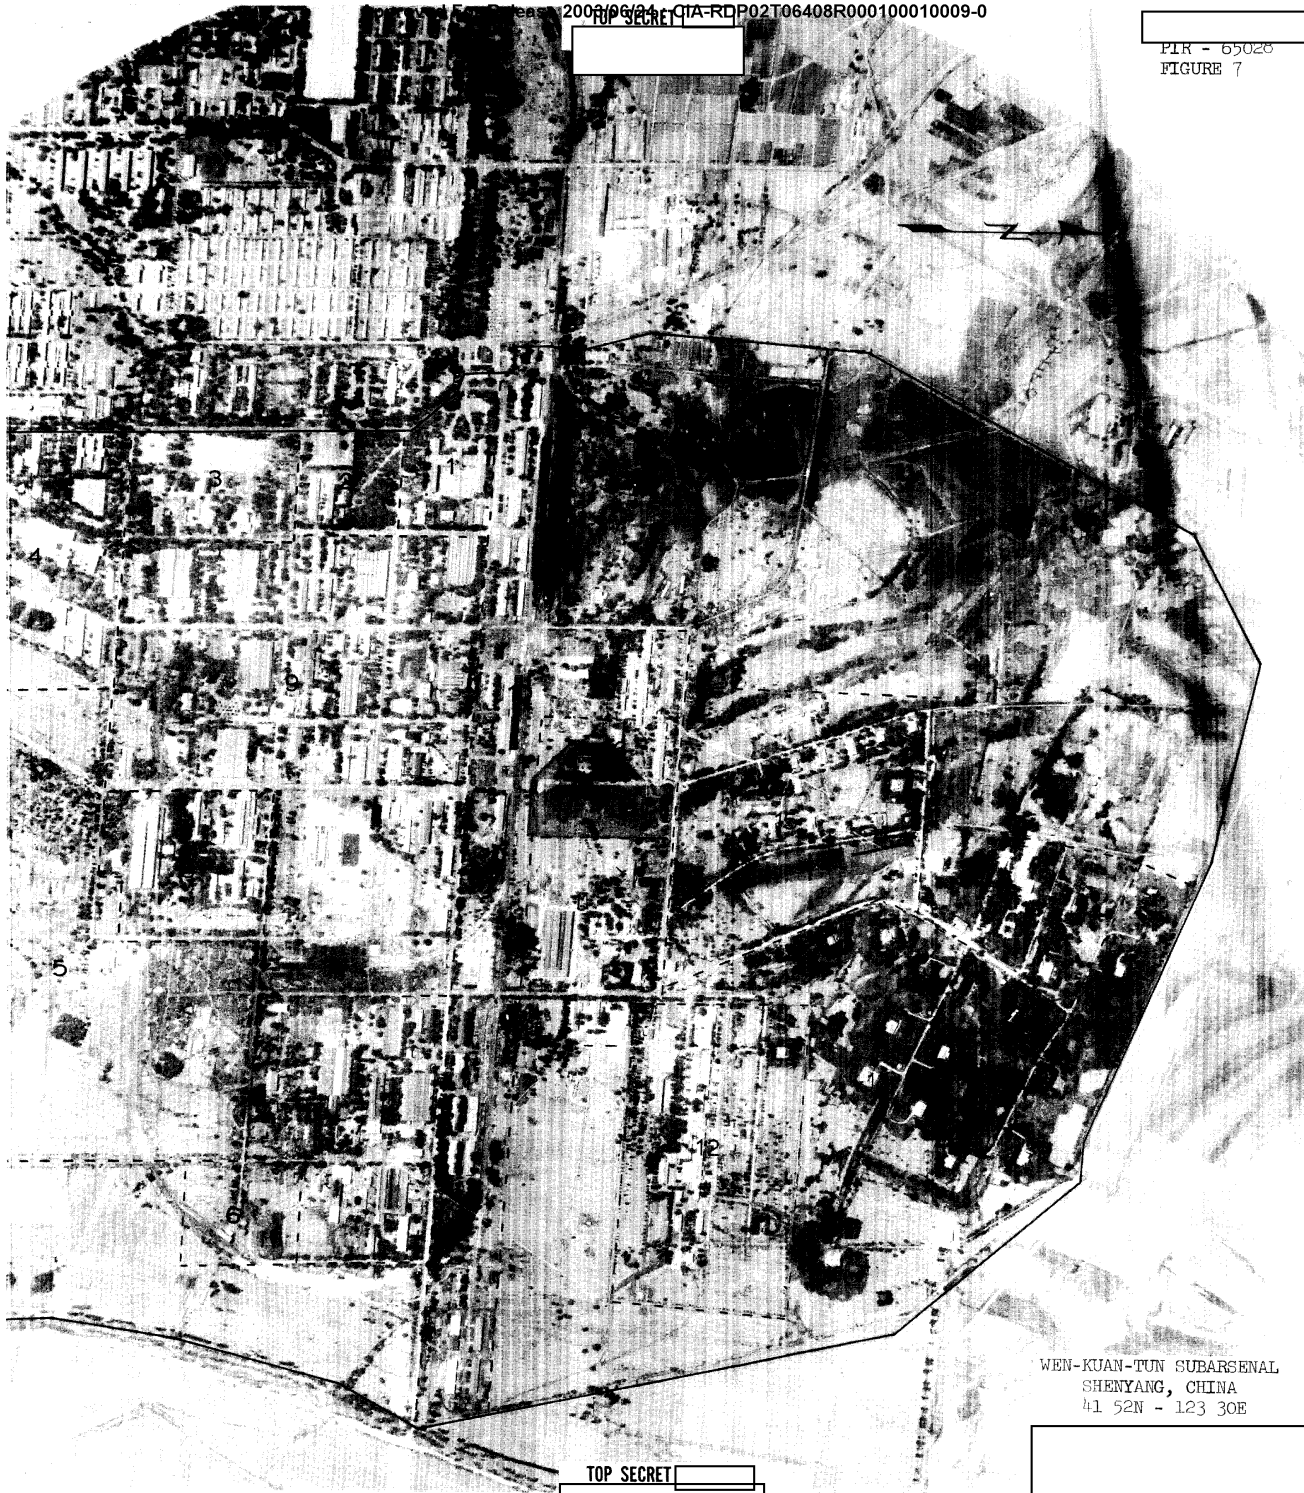
PLR - 65026
FIGURE 7

The plant can be divided into two major sections on the basis of function. North of the rail spur entering the west side of the plant many structures are revetted or otherwise protected as is typical in explosives processing and loading; to the south are many shop/assembly buildings, typical of metal fabrication industries. The following descriptions of separate functional areas are keyed to Figure 7.

- (1) Administration area, with one large building, several small service and security sheds, and a boiler house
- (2) Motor pool, one probable shop, two probable warehouses, and vehicles present on several missions

- (3) Area of miscellaneous activity, containing small shops, boiler house, warehouse, and unidentified open storage
- (4) Administration area, also includes two small shops and a boiler house

- (5) Open area except for small sawmill in northeast corner, logs stockpiled along rail spur and open lumber storage west and south of sawmill
- (6) Possible POL receiving point, two storage tanks, rail served receiving point, boiler house nearby

- (7) Metal processing and fabrication area, large furnace/foundry section, three large probable machine shops, several workshops, and a boilerhouse
- (8) Probable metal processing and casting area, with furnace building, probable forge/foundry area, shops, and a boiler house

- (9) Fabrication section, several large machine shops, numerous small workshop/machine shops, three boiler houses, warehouses, one possible foundry, and probable assembly buildings

- (10) Shipping/receiving section for plant, rail served, includes warehouses, large coal stockpile, and unidentified open storage
- (11) Unidentified processing area, large storage/shop building, boiler house, unidentified group of interconnected processing buildings, and probable warehouses

- (12) Secured explosives loading line, probable booster loading and possibly fuzes, series of buildings connected by passageways, two sections have visible blast walls, adjacent revetted storage, and miscellaneous inert storage and support buildings

- (13) Explosives storage area, ten revetted storage magazines, one revetted possible explosives processing building, a boiler house and one unidentified building

- (14) Explosives processing area, unidentified as to type
- (15) Initiator area, probable production of lead azide from sodium azide, includes precipitation buildings, processing buildings, and storage; probable pelleting building indicates initiator loading

- (16) Loading line, five buildings connected by passageways with numerous nearby support and service sheds; light protection indicates a fairly safe operation such as possible final assembly of various shell components; southeast of the loading line is an unidentified separately secured area containing a tall building and two large rectangular mounded areas

WEN-KUAN-TUN SUBARSENAL
SHENYANG, CHINA
41 52N - 123 30E

The basic layout of this plant and many of the buildings remain unchanged since first coverage in [REDACTED]. The only significant changes in plant production areas between [REDACTED] were in the explosives loading and processing sector. Probable booster loading line (item 12) was completely rebuilt, although evidently incorporating portions of a previously existing line. Explosives processing area (item 14), was erected at the site of previous explosives storage. A loading line (item 16) was constructed and this project also utilized a previously existing building at this site. No extensive changes were noted in the production areas of the metal working and fabrication sections of this arsenal. However, the small sawmill (item 5) was added, several buildings were erected in the administration area (item 4), and of course there were a few changes in warehouses and open storage sites. The southwestern portion of this plant was also covered in [REDACTED]. A majority of the above noted changes in production sections had already occurred by this date. Comparison of [REDACTED] coverage with satellite photography of [REDACTED] reveals that plant facilities have remained at a nearly static level. Construction has started on a new warehouse (item 10), replacing five small sheds, since [REDACTED] a new probable warehouse and two unidentified buildings are presently under construction (item 9), and a

probable POL storage tank under construction in [] has been completed (item 6).
